NATIONAL TRANSPORTATION SAFETY BOARD

AIRCRAFT ACCIDENT REPORT

In-flight Breakup Over the Atlantic Ocean
Trans World Airlines Flight 800
Boeing 747-131, N93119
Near East Moriches, New York
July 17, 1996

**NTSB/AAR-00/03
DCA96MA070
PB2000-910403
Notation 6788G
Adopted August 23, 2000**

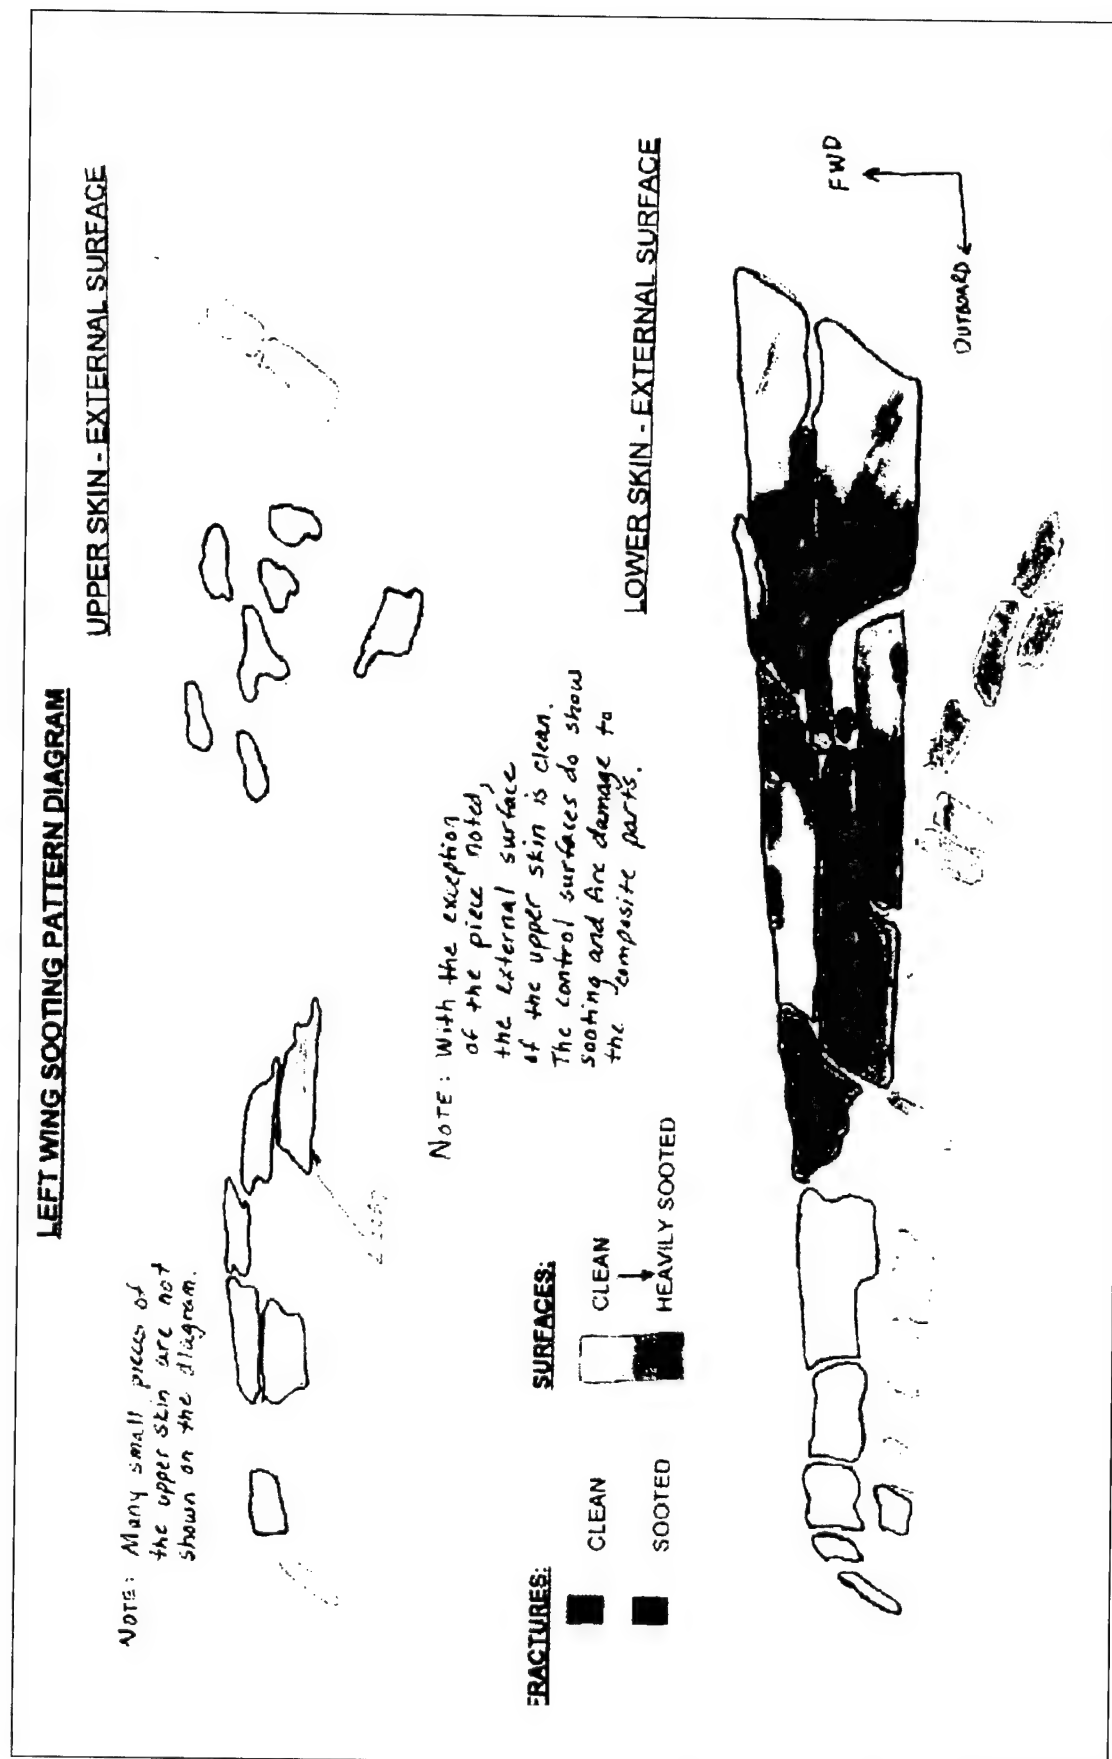
LEFT WING SOOTING PATTERN DIAGRAMUPPER SKIN - INTERNAL SURFACE

NOTE: Many small pieces of the upper skin are not shown on the diagram.
